ONE SEAM AT A TIME: INTERACTIVE QUALITY ASSURANCE TO IDENTIFY COAL SEAMS DURING FOUNDATION CONSTRUCTION

Christopher Lawler, P.G. Quanta Subsurface, Spokane, WA, 509.789.7747, CLawler@QuantaSubsurface.com
Matthew Runion, P.E., Quanta Subsurface, Blacksburg, VA, 509.789.7747, MRunion@QuantaSubsurface.com

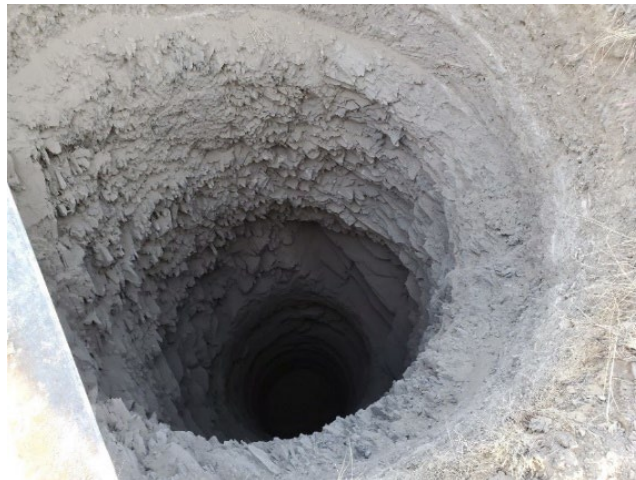
Figure 2. Typical Hole Conditions

Foundation designs allowed for flexibility based on conditions encountered in the field; the success of which hinged on the development and implementation of a robust, proactive QA program. Licensed, professional geologists with prior foundation construction oversight experience would be onsite to oversee the Contractor's Quality Control (QC) program, verify encountered geotechnical conditions against the design assumptions, and assist in anticipating and facilitating required design changes. The program was tailored to allow for real-time design support throughout construction with little to no delay, and was accomplished by establishing an interactive network between the Owner, Engineer, Contractor and QA/QC team.

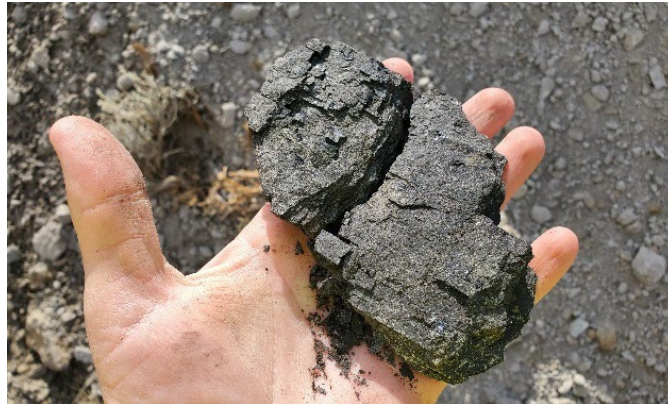
At Site A, a large unexpected coal seam was identified by QA personnel and communicated to Engineering. The thickness, orientation, and depth of the seam varied at each of the four lattice tower legs, and the foundation designs were analyzed separately.

Original drilled shaft designs at all four legs were to be 3 feet in diameter and 15 feet deep. At leg one, the coal seam extended from 7 to 14.5 feet below the ground surface, and the design was required to be extended 1.5 feet to an embedment depth of 16.5 feet. At leg two, the coal seam extended from 6.5 feet to 13 feet below the ground surface, and the design was required to be extended 1 foot to an embedment depth of 16 feet. At legs three and four, a 4- to 5-foot coal seam was encountered at depths of 17.5 feet and 18.5 feet respectively. Analysis of the shafts at these legs showed sufficient geotechnical resistance when the shaft was extended to one foot below the bottom of the coal seam, per the project requirements.

Figure 4. Coal Encountered During Drilling

The analysis at Site A was conducted during construction, with information continuously flowing between QA and Engineering. QA monitored drilling activities, characterized auger cuttings, and communicated pertinent data to Engineering. Engineering then assigned suitable geotechnical strength parameters to bearing material and provided QA with direction on how to proceed. For each leg, engineering instruction was efficiently turned around within two hours of receiving QA data to ensure construction schedules remained on track.

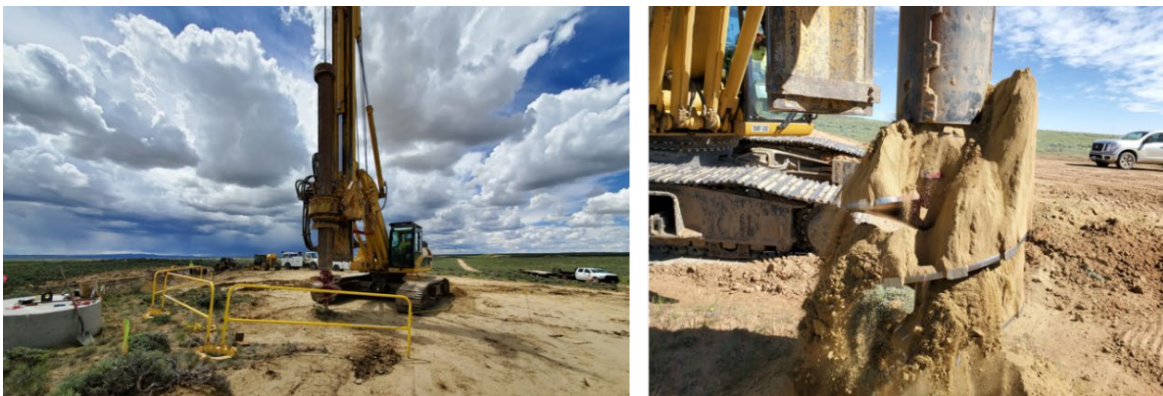
At Site B, the encountered soils did not match the assigned soil profile. QA personnel classified them as loose silty sands, which did not meet the required soil profile for very dense, non-cohesive soils. These conditions were fairly consistent between the four tower legs at this location. The pre-construction design, anticipating very dense material to depth, specified a 3-foot diameter shaft embedded 15 feet below the ground surface.

Figure 5. Encountering Loose Silty Sands While Drilling

The change in condition was identified, characterized, and communicated to Engineering. Engineering provided a response within the hour, specifying that the shaft be extended 6 feet to a total embedment depth of 21 feet. Drilling continued until unanticipated fresh, strong quartzite was encountered at a depth of 20 feet. Once again, the change was identified, characterized, and communicated to Engineering. A second redesign was efficiently developed factoring in the tooling and materials the Contractor had readily available. The shaft diameter was ultimately increased to 3.5 feet. This change allowed for a 20-foot shaft depth, eliminating the need to drill further through the quartzite while still meeting required capacities.

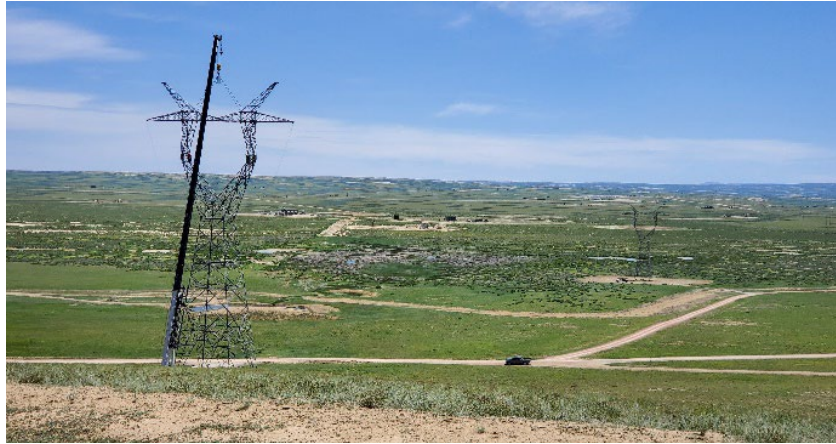
Figure 6. Tower Erection on Completed Foundation
